Remediation of the RVSD Property at 2000 Larkspur Landing Circle:

Updated Work Plan, Cost Estimate, and Implementation Actions

(March 15th 2017)

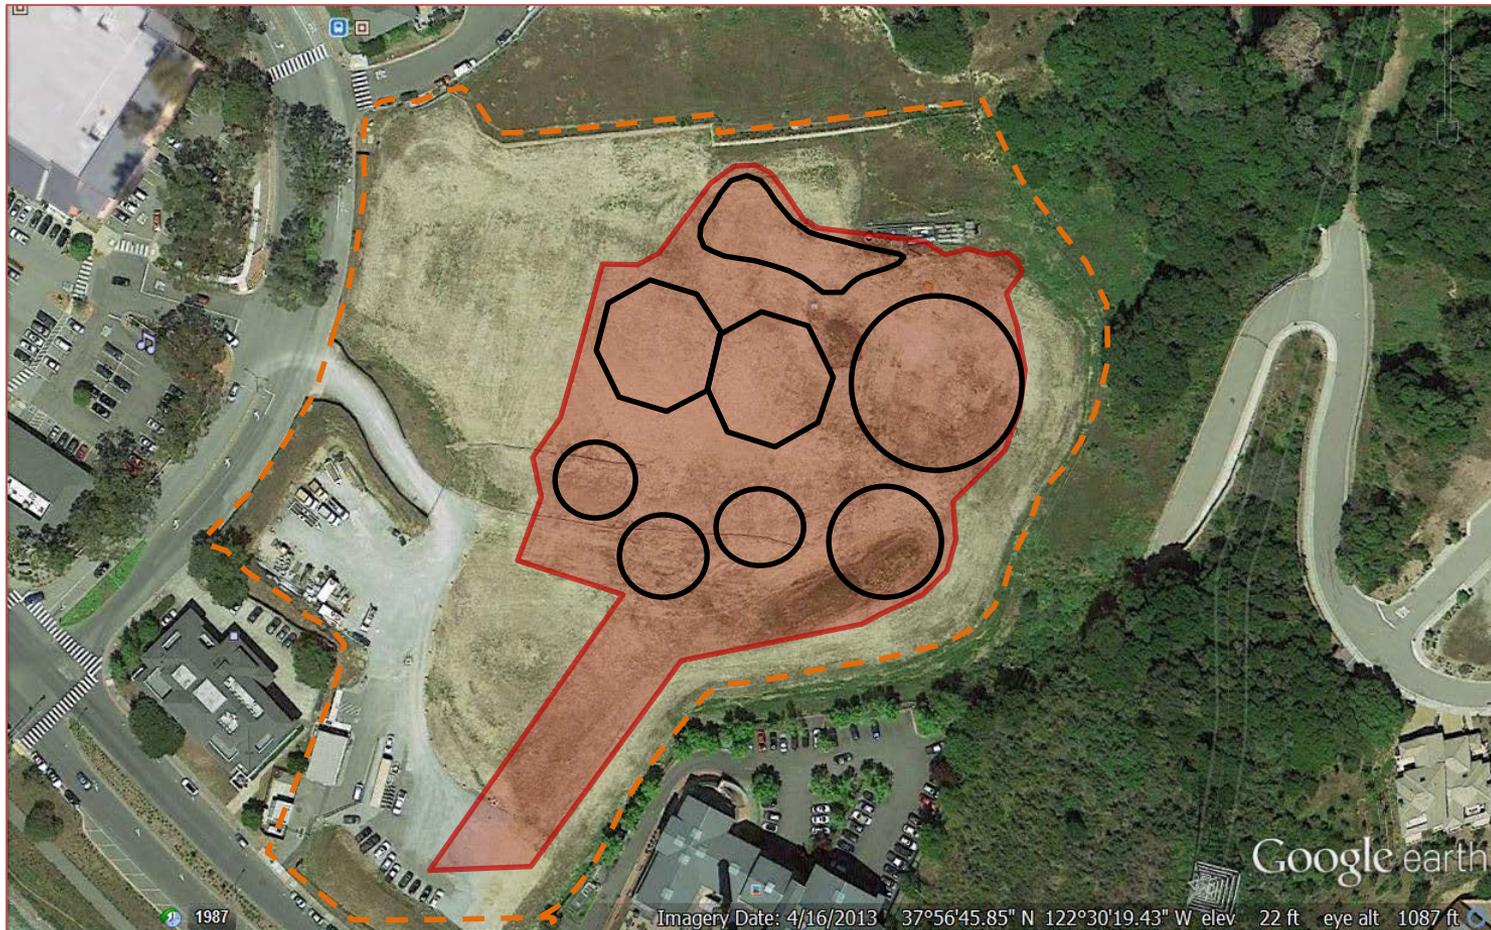
Review of Initial Site Conceptual Model (Former WWTP Demolition Limits)

Site Boundary

Limits of WWTP Demolition

Location of Demolished Structure (Approximate)

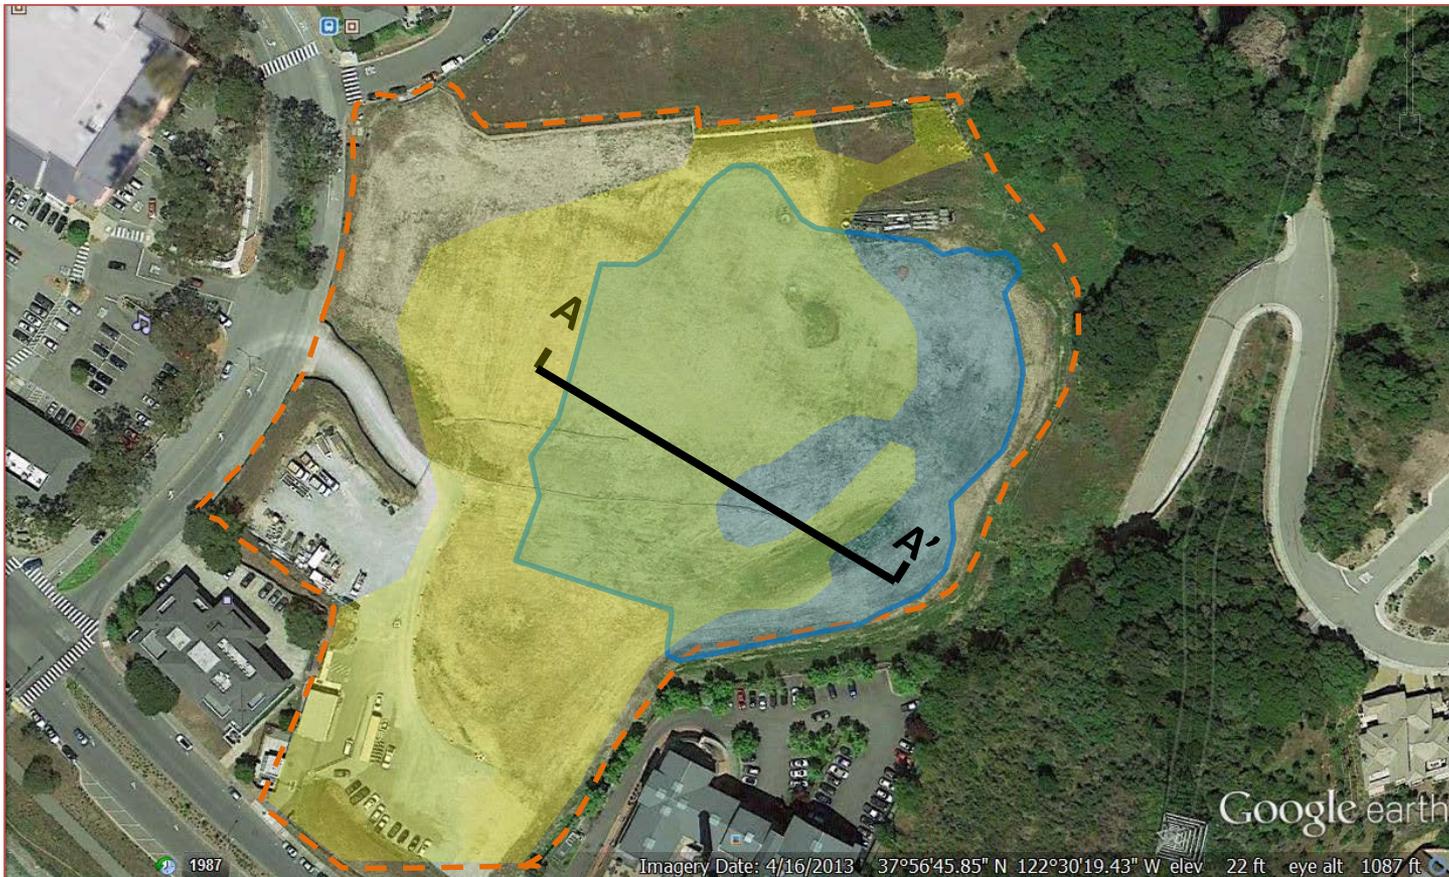
Review of Initial Site Conceptual Model (Backfill Limits)

Site Boundary

Limits of Construction Backfill
(Initial Imported Soil & crushed concrete)

2012 Regraded Area

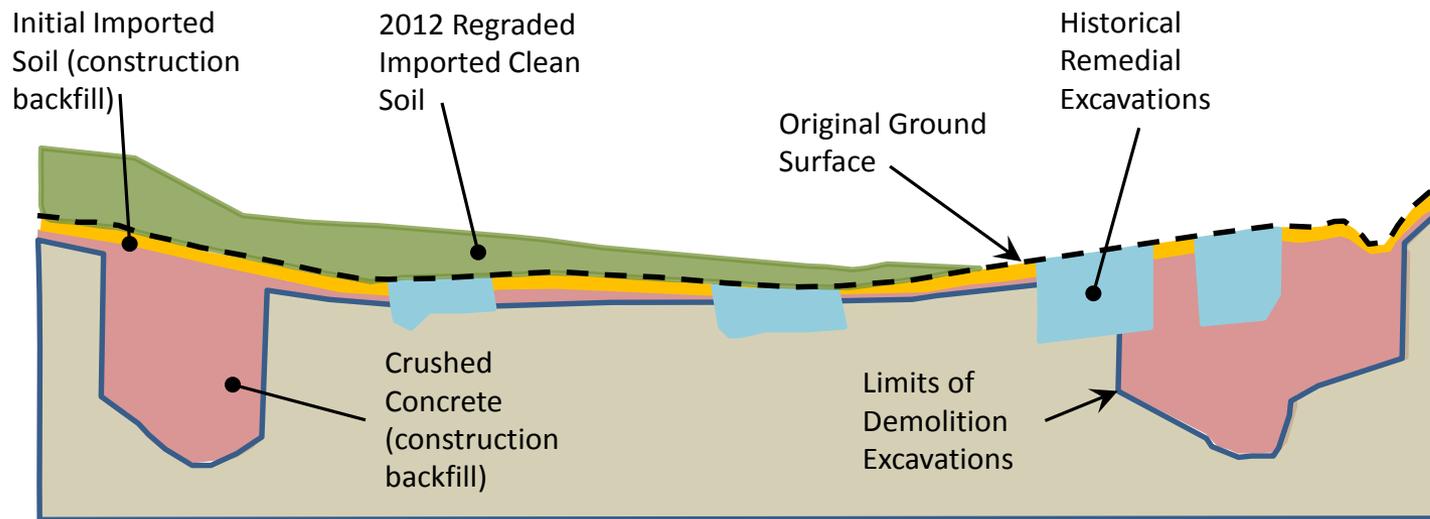
Review of Initial Site Conceptual Model (Representative Cross Section)

This initial model of the Site has been refined based upon the results of the site characterization work performed in the Winter of 2016.

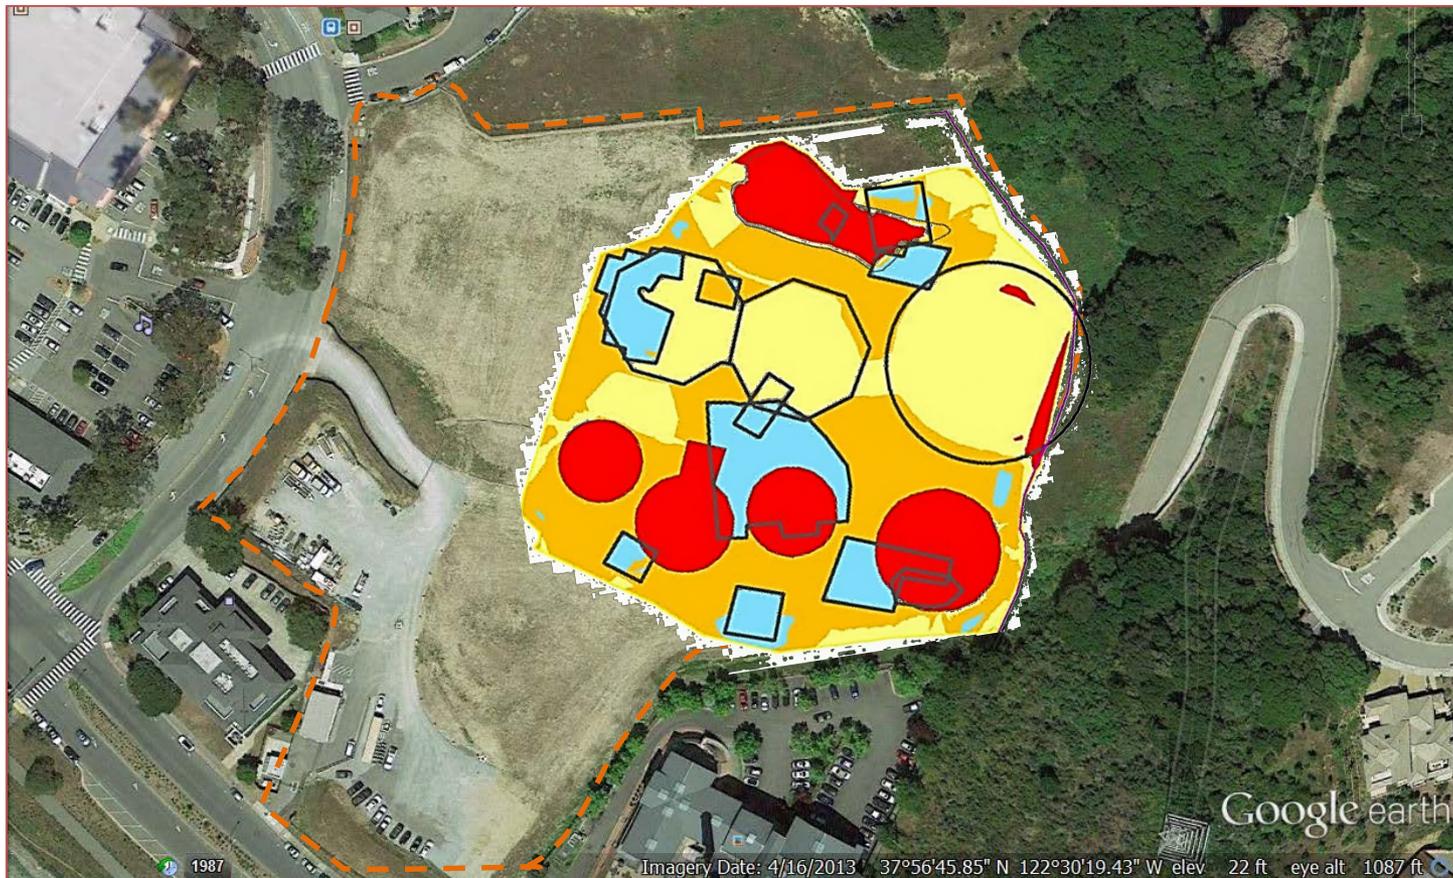
Review of Initial Site Conceptual Model (Impacted Areas)

- Site Boundary
- Historical Remedial Excavations
- Construction Backfill 0-2 ft
- Construction Backfill 2-4 ft
- Construction Backfill 4-20 ft

This initial model of the Site has been refined based upon the results of the site characterization work performed in the Winter of 2016.

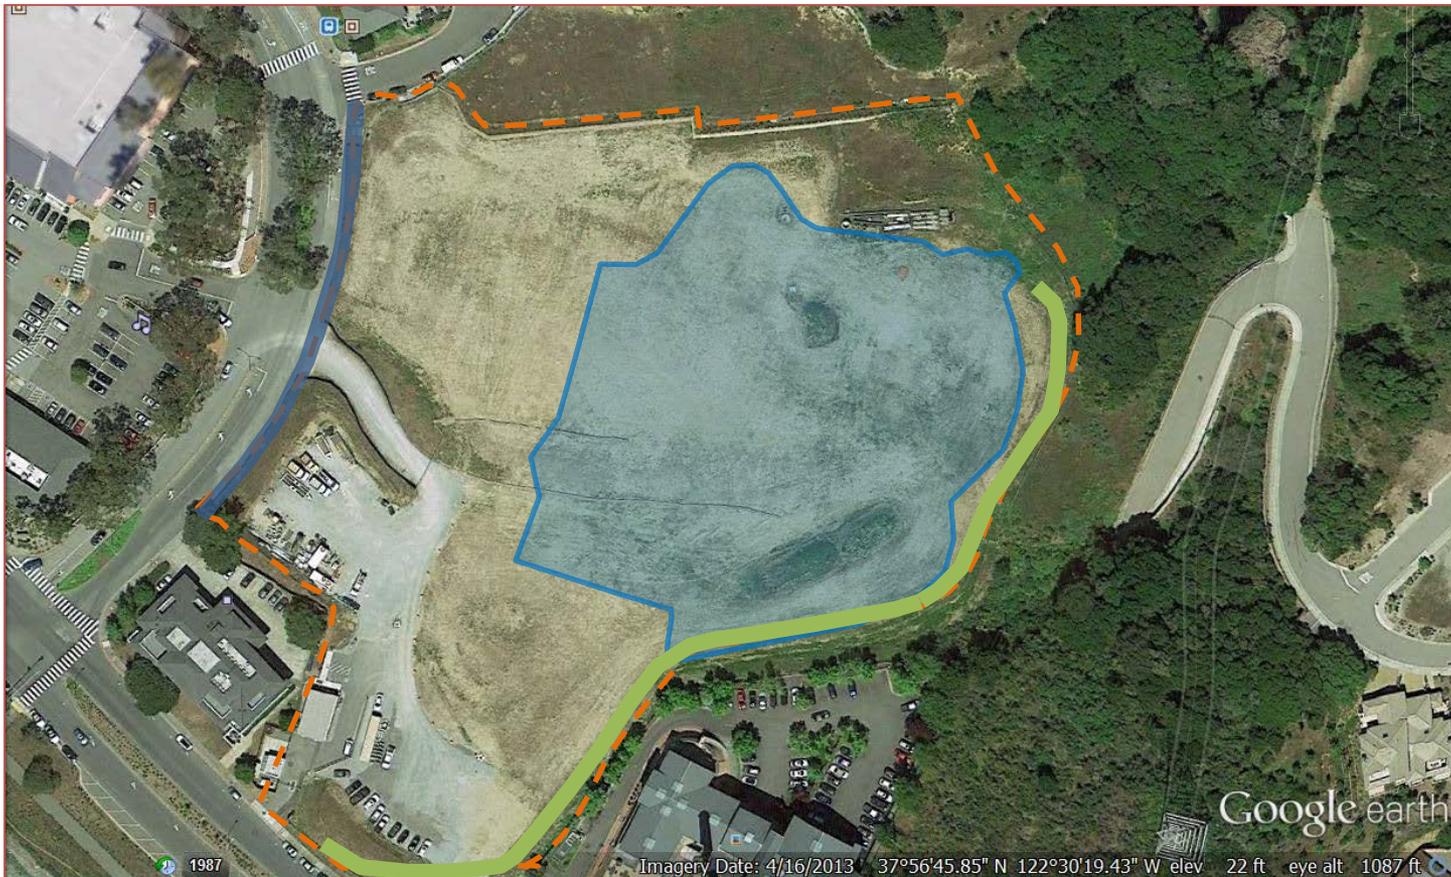
Site Characterization Areas

Site Boundary

Limits of Construction Backfill

Sidewalk Area

Drainage Swale

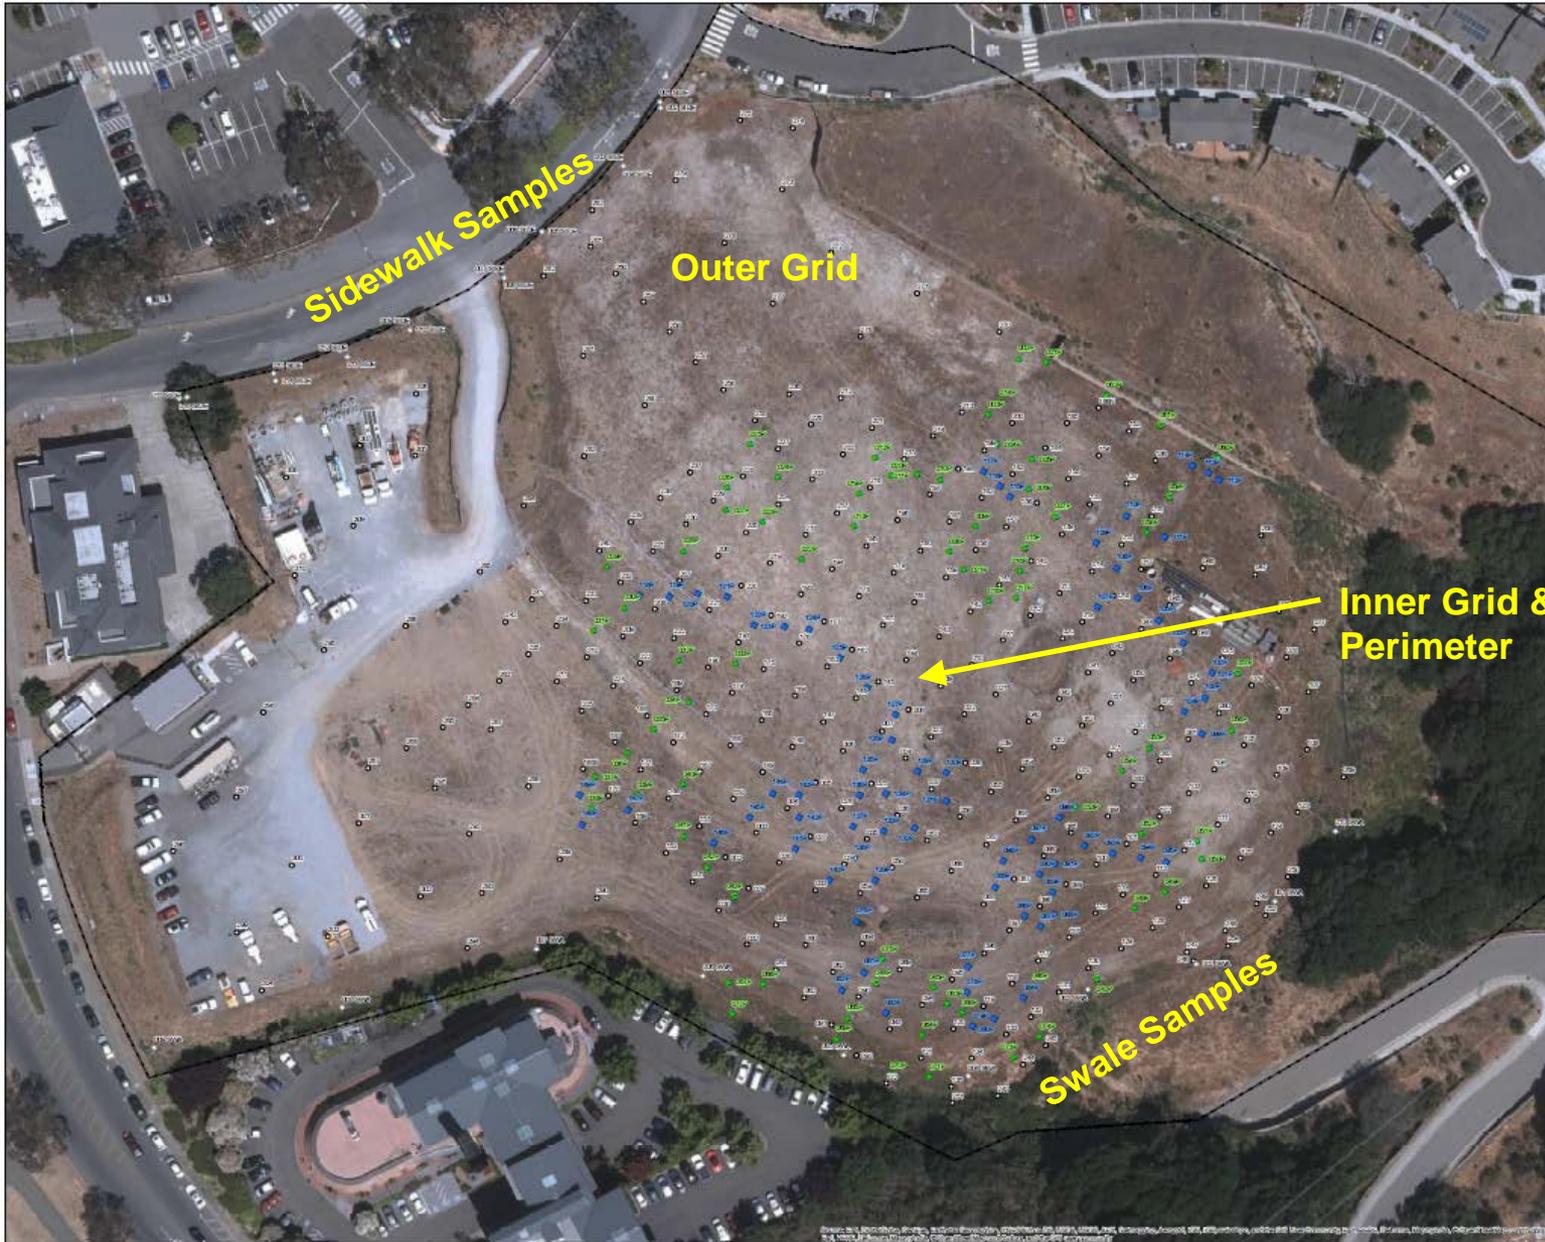
Sample Collection

- Sidewalk and Swale Surface and Near Surface Sample Locations
- Grid Boring
- Interior Perimeter Boring
- ◆ Perimeter Boring
- Approximate Property Boundary

- Grid Boring
- Interior Perimeter Boring
- ◆ Perimeter Boring

- Site characterization implemented with following key objectives:
 - Determine limits of debris and soil removal
 - Collect in-place verification samples to confirm those limits to the satisfaction of EPA.
 - Characterize the waste for disposal (quality and quantity)
- Meeting these objectives supports contracting for implementation of the cleanup
- Approximately 500 boring locations with 1,800 samples
- Bore hole logging, chemical analysis, 3D modeling

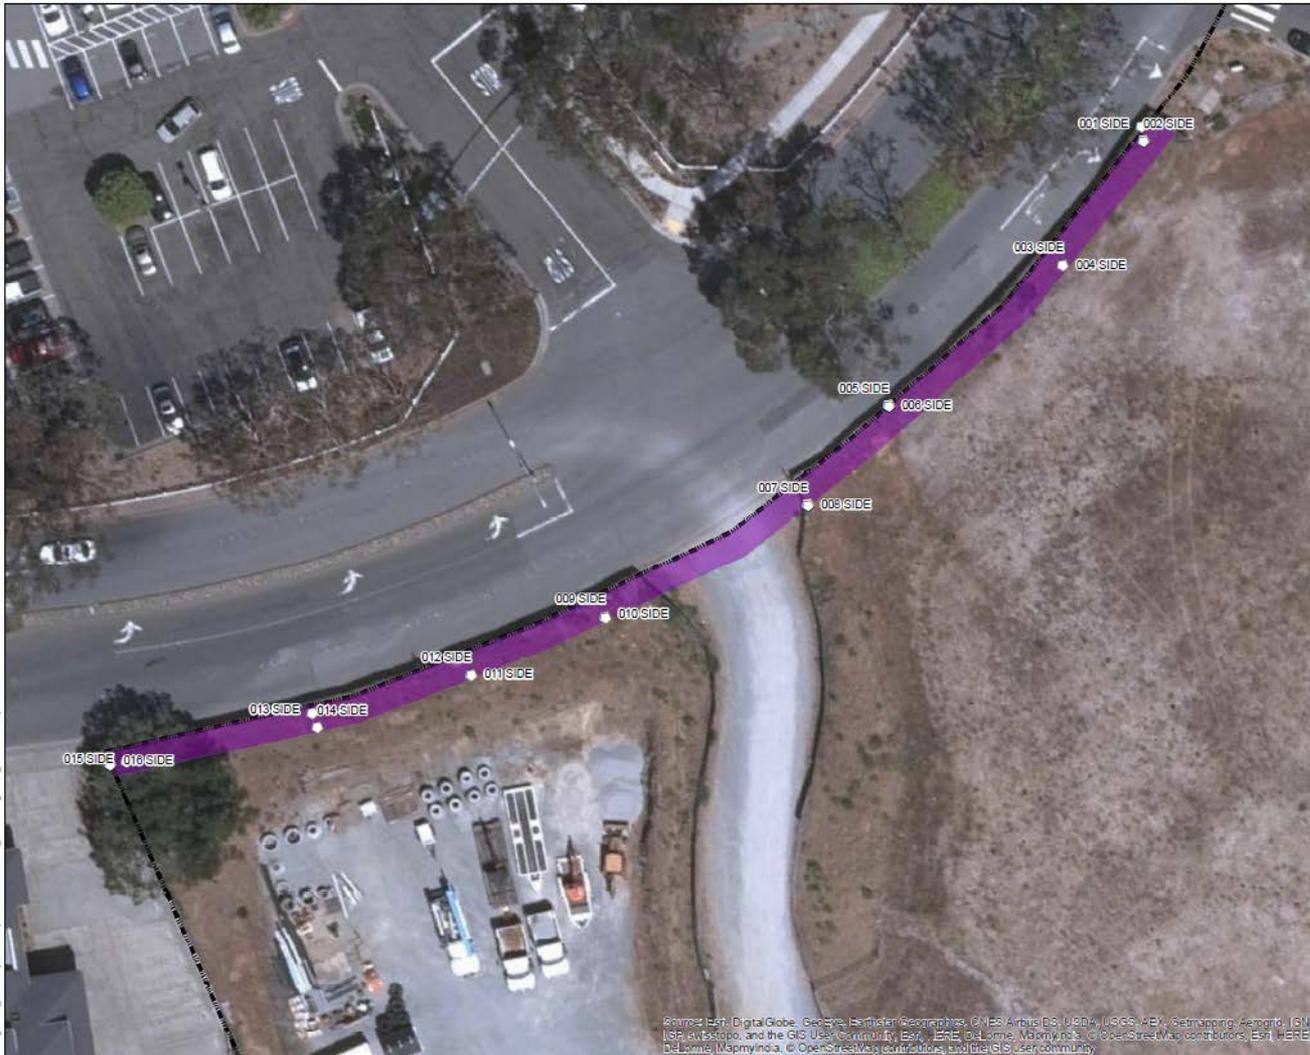
Characterization Results (Sidewalk Area)

Sidewalk Surface and Near Surface Sample Locations
-

Conceptual Sidewalk (8 ft wide)
-

PCBs not detected

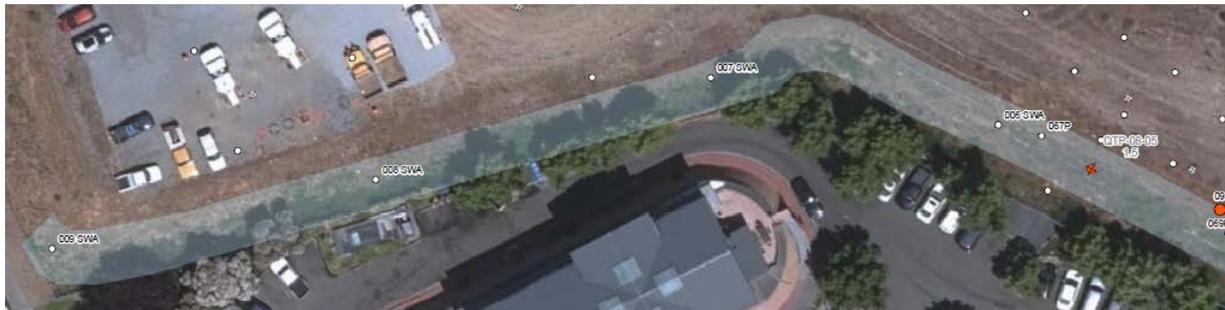
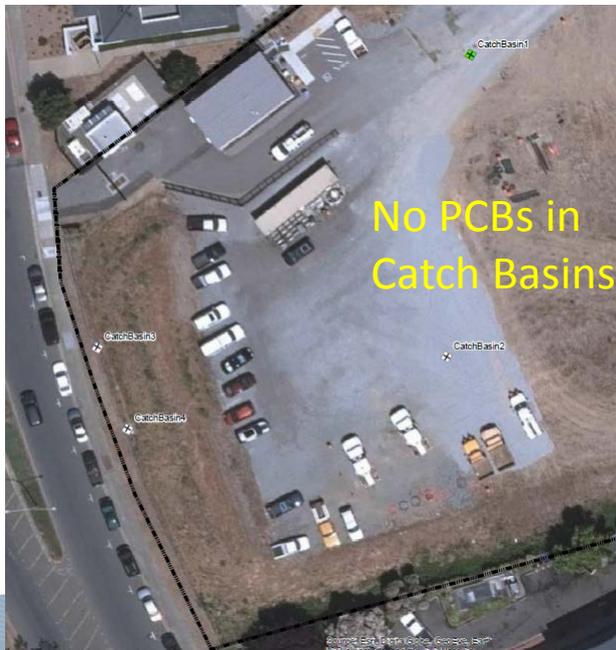
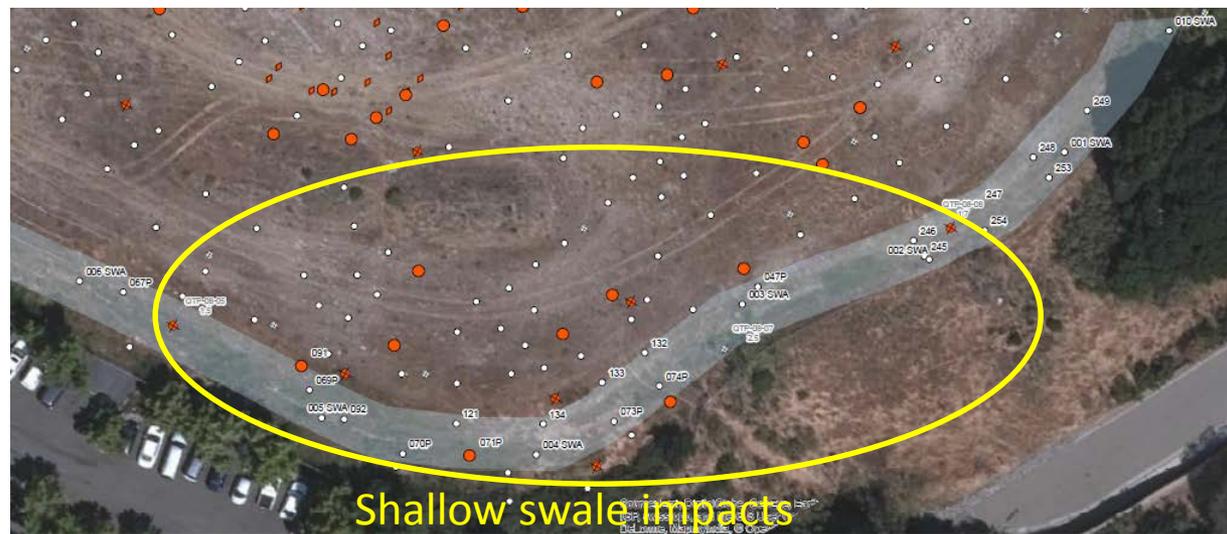
Characterization Results (Drainage System)

- Max Total PCBs Below 0.24 mg/kg (Includes detects and non-detects)
- Max Total PCBs Equal to or Exceeds 0.24 mg/kg

- ⊕ Total PCBs Below 0.24 mg/kg (Includes detects, non-detects, and locations without data)
- ⊕ Total PCBs Equal to or Exceeds 0.24 mg/kg
- ◆ Questa Excavation J, K, and H Confirmation Samples Exceeding 0.24 mg/kg
- ◆ Questa Excavation G Confirmation Samples Exceeding 0.24 mg/kg

Maximum Extent of Swale (20 ft wide)

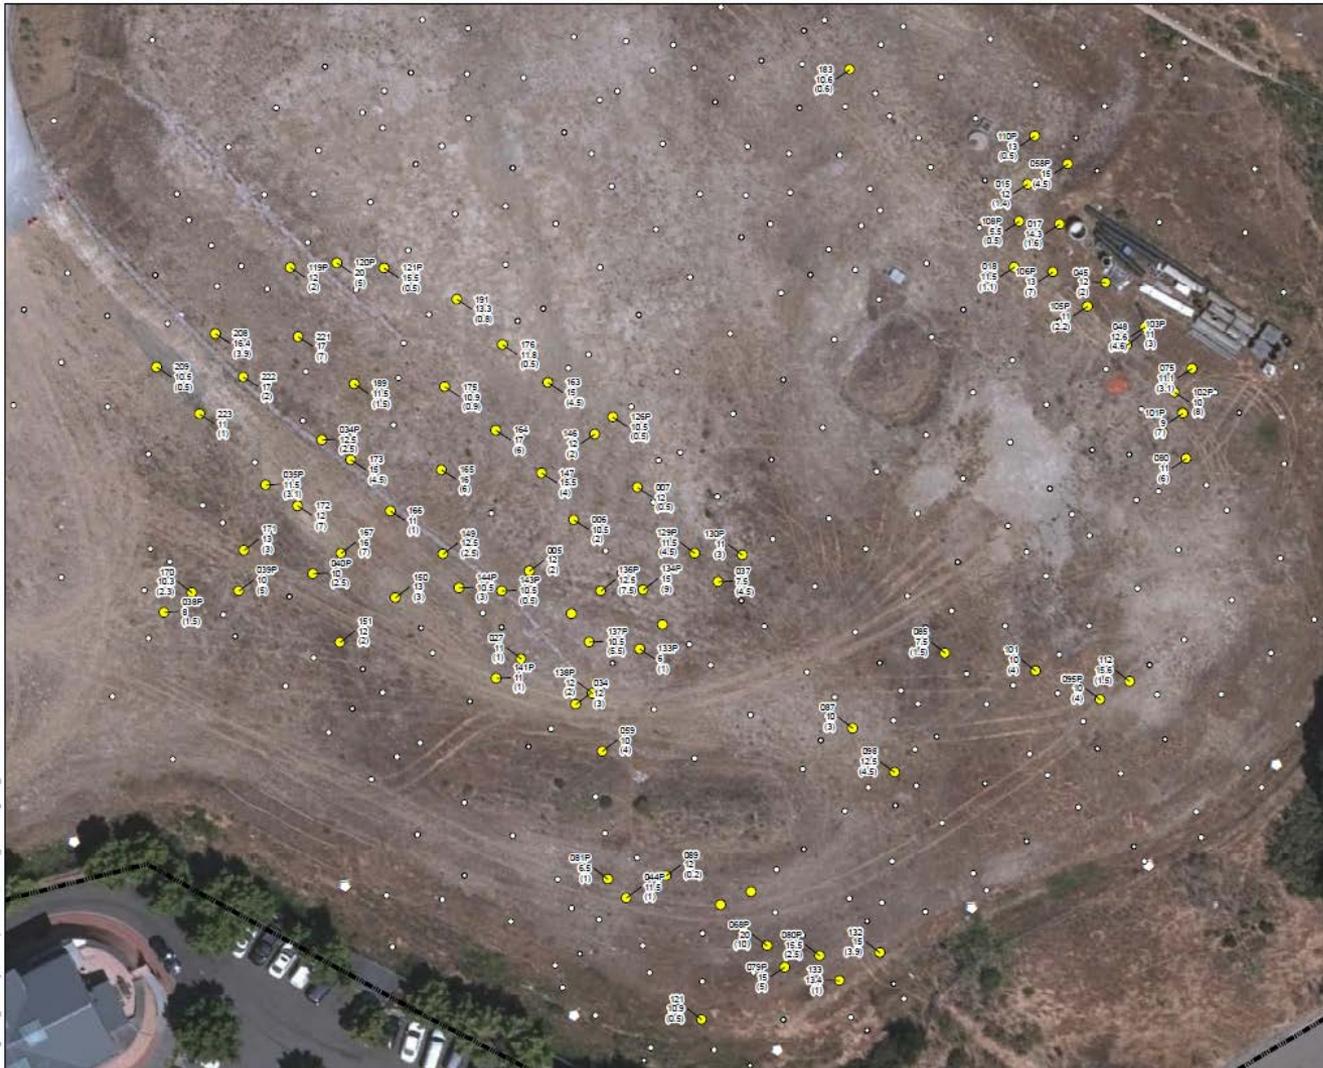
Characterization Results

Demolition Backfill Encountered In 2016 Boring
-

2016 Boring Location
-

- Deposits distinct from other fill material.
- Deposits generally not as laterally extensive as anticipated.
- Deposits not as thick as anticipated.

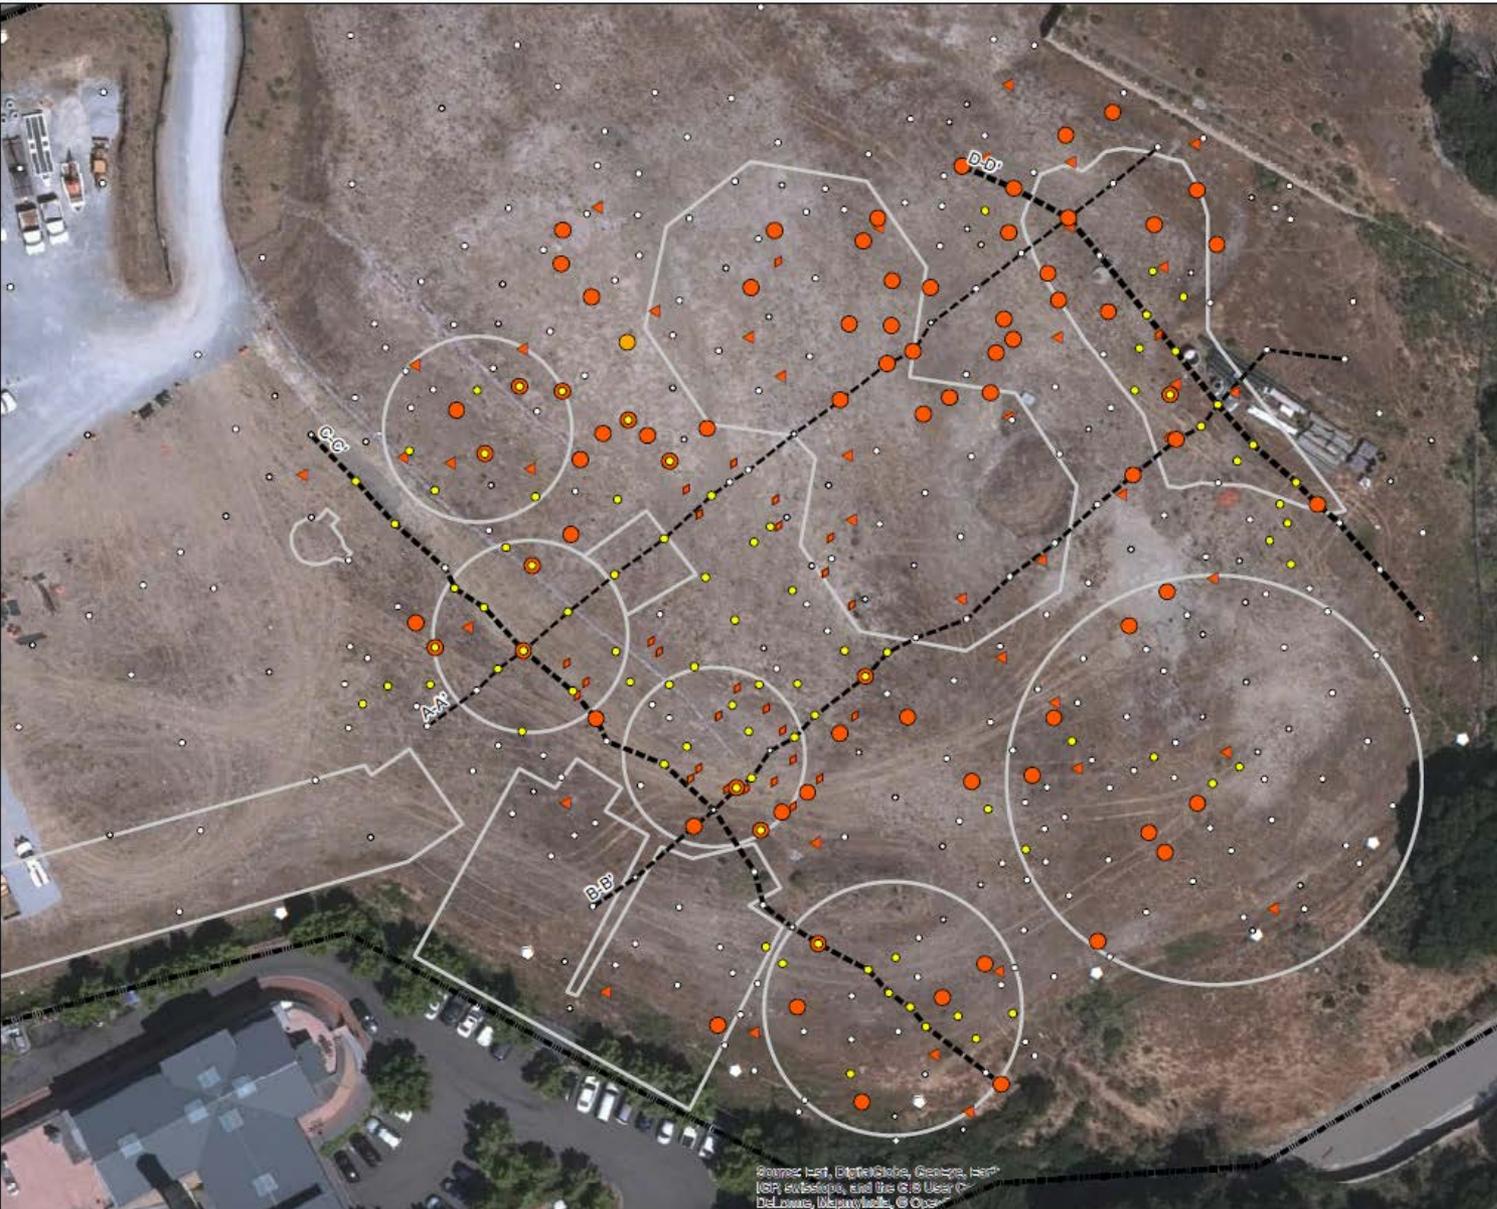
Characterization Results (Import Fill)

- Soil impacts more extensive laterally than anticipated.
- Soil impacts at various depths, including the surface.
- Very low levels of PCBs confirmed

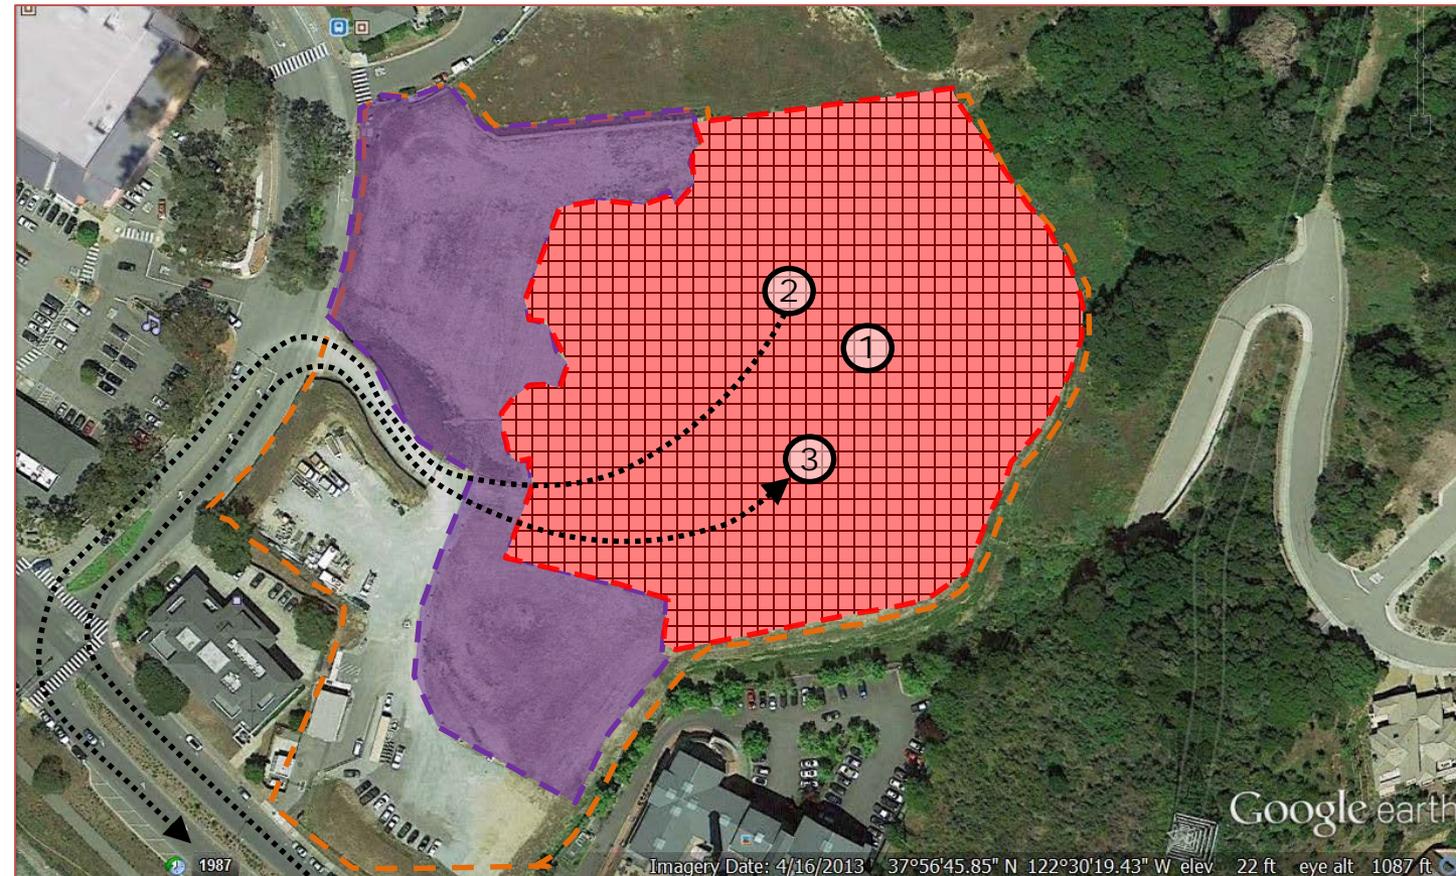
Remediation Sequence

Site Boundary
-

Loading and Off Haul Operation
-

Excavation Area

Site Preparation and Layout Limits of Excavation
-

Excavate, Direct Load, and Off Haul Soil and Debris
-

Restoration Backfill with Clean Import and Stabilize the Site

- Prepare remediation contract documents for bidding and select contractor.
- Prepare site for earthwork and hauling operations.
- Excavate demolition debris and PCB-impacted soils and load directly to trucks for offsite disposal.
- Backfill with clean imported material, regrade, and restore the site.
- Obtain “no further action” determination from EPA.
